**CONTINUING ELIGIBILITY INSPECTION (CEI) REPORT**  
***FOR FLOOD CONTROL PROJECTS***

1. Project Name: Namo River FCP
2. Date of Inspection: February 6, 2002

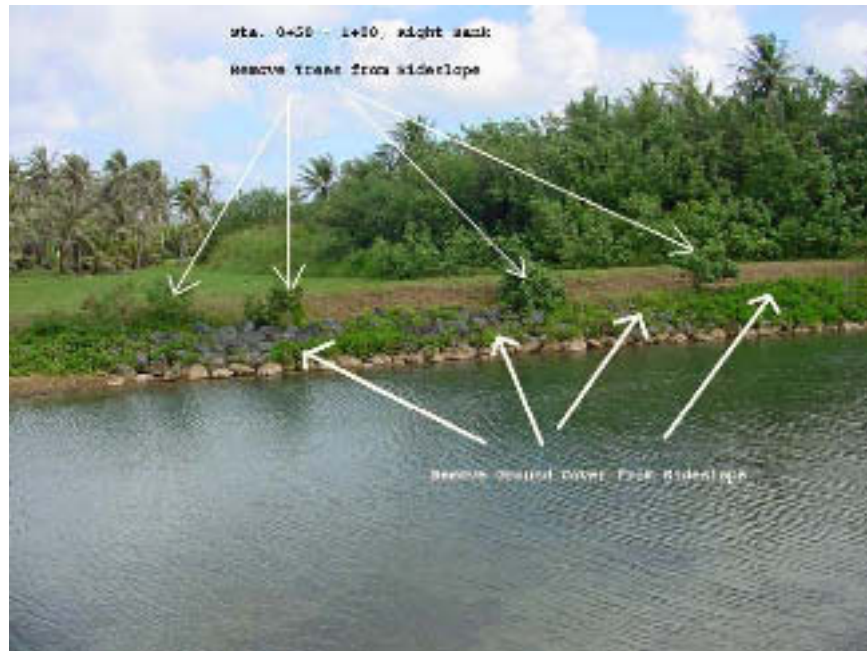
a. Sta. 0+50, Right Bank (RB), remove vegetation from riprap slope protection.

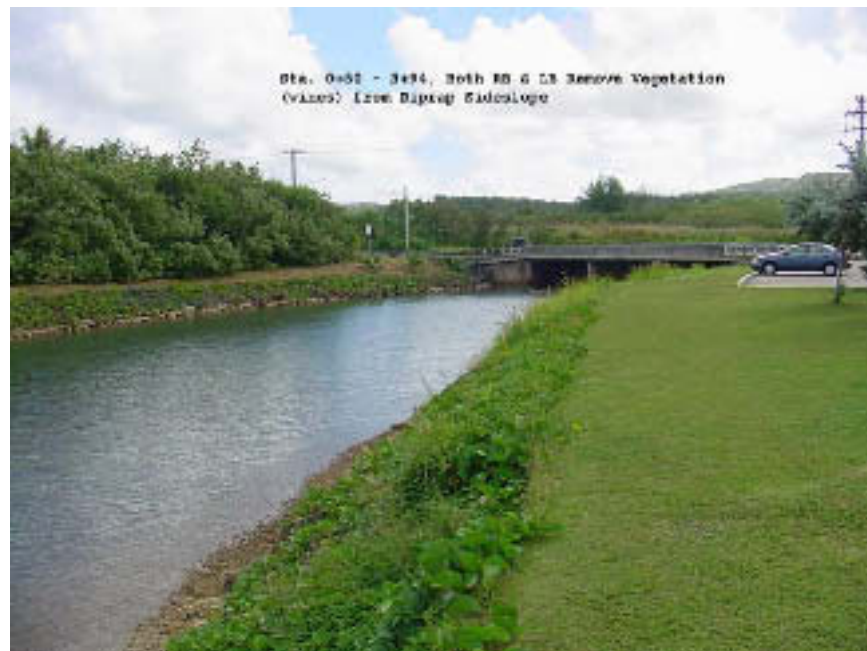
b. Sta. 0+50 - 3+95, Right Bank & Left Bank, (LB), remove vegetation from riprap slope protection.

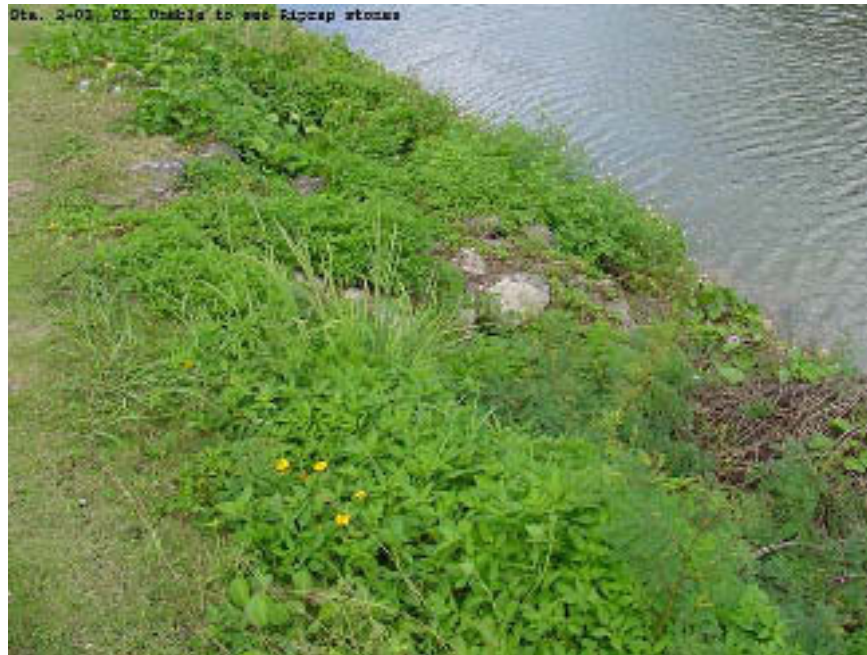
c. Sta. 2+00, Left Bank, (LB), remove vegetation from riprap slope protection, unable to verify riprap placement.

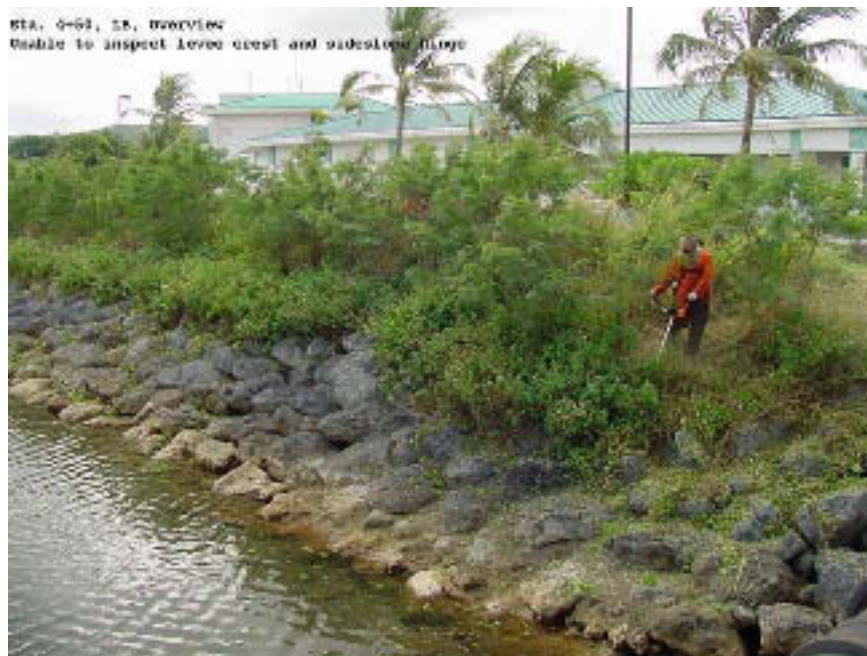
d. Sta. 4+55, RB, remove vegetation from levee and riprap slope protection, unable to verify riprap placement (DPW workers initial effort).

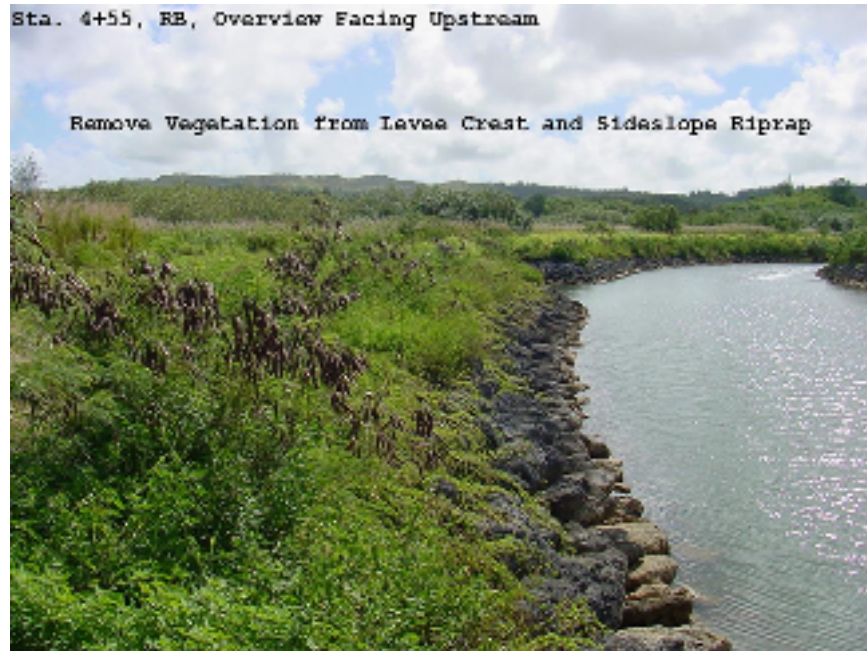
e. Sta. 4+55, RB, remove vegetation from levee and riprap slope protection, unable to verify riprap placement.

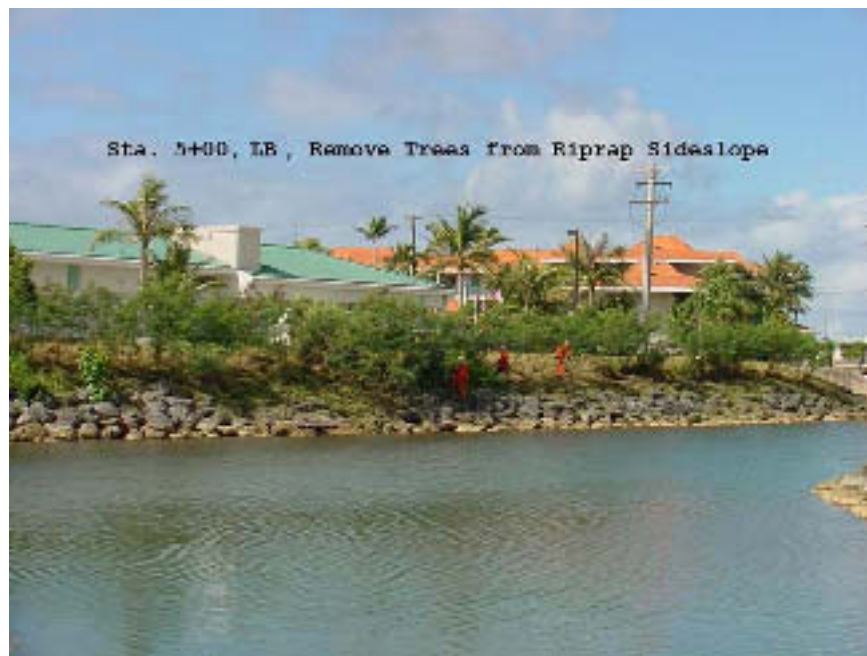
f. Sta. 5+00, RB, remove vegetation from levee and riprap slope protection, unable to verify riprap placement.

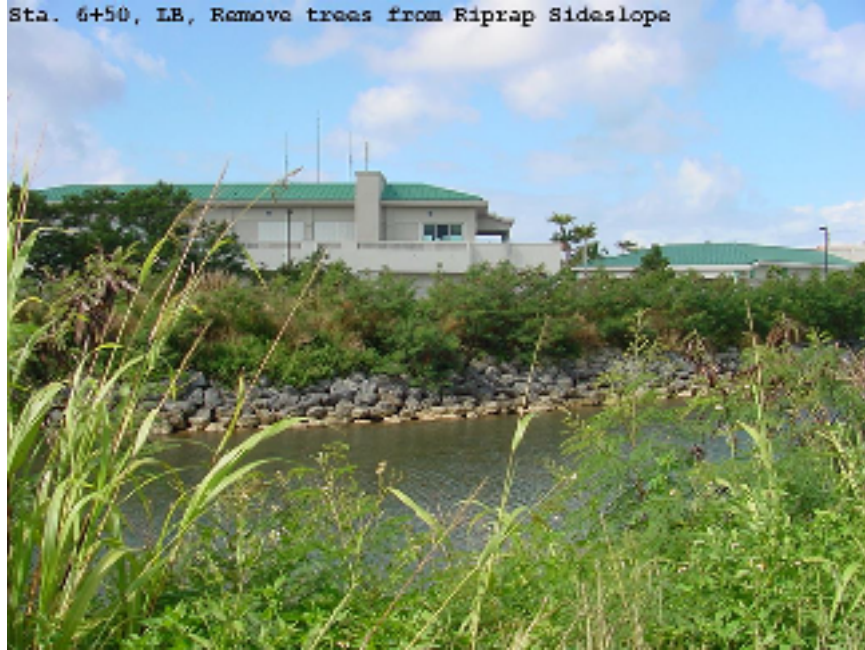
Sta. 6+50, LB, Remove trees from Riprap Sideslope

g. Sta. 6+50, RB & LB, remove vegetation from levee and riprap slope protection, unable to verify riprap placement.

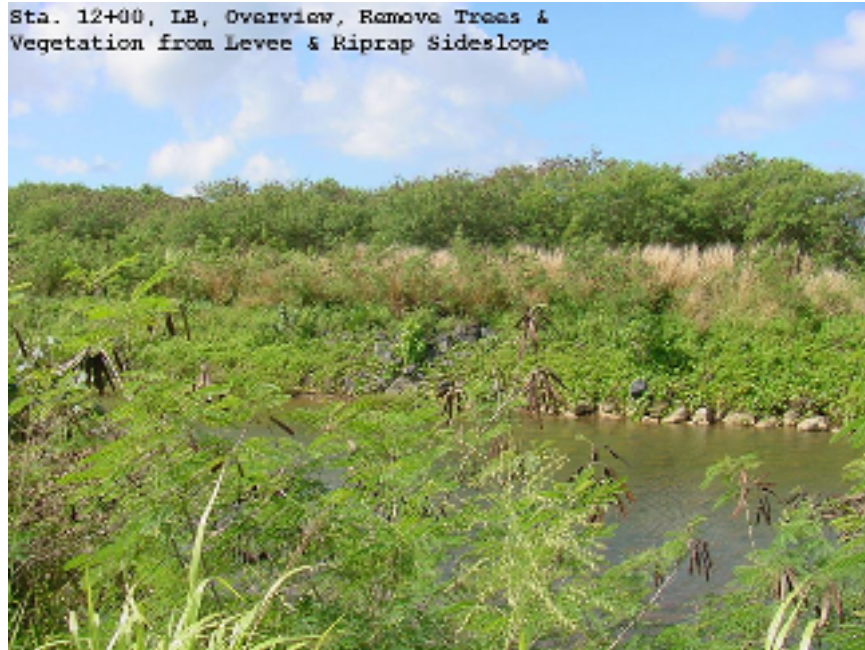
Sta. 12+00, LB, Overview, Remove Trees & Vegetation from Levee & Riprap Sideslope

h. Sta. 12+00, RB & LB, remove vegetation from levee and riprap slope protection, unable to verify riprap placement.

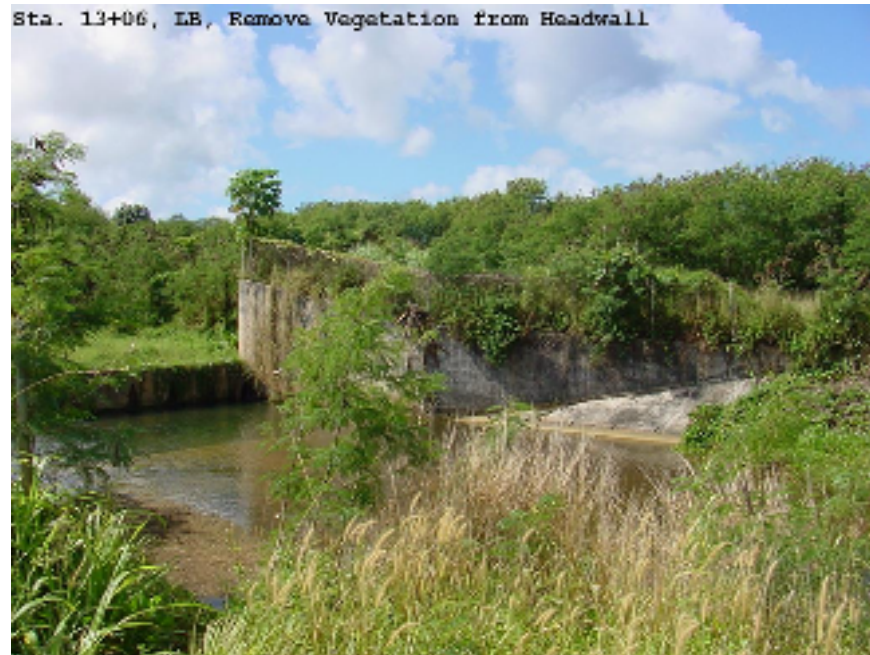
- i. Sta. 13+06, LB, remove vegetation from levee, weir headwalls, fence and riprap slope protection, unable to verify riprap placement.

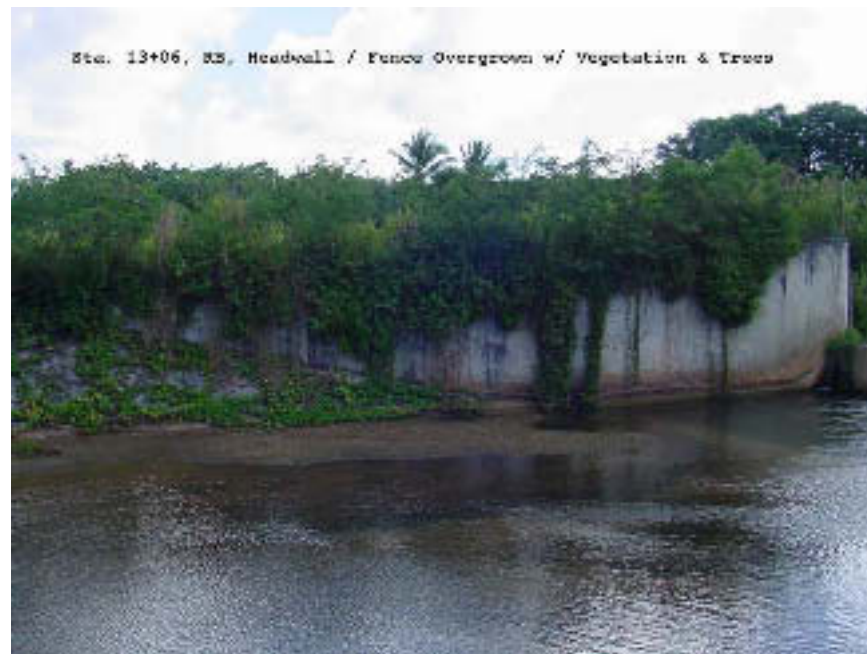
- j. Sta. 13+06, RB, remove vegetation from levee, weir headwalls, fence and riprap slope protection, unable to verify riprap placement.

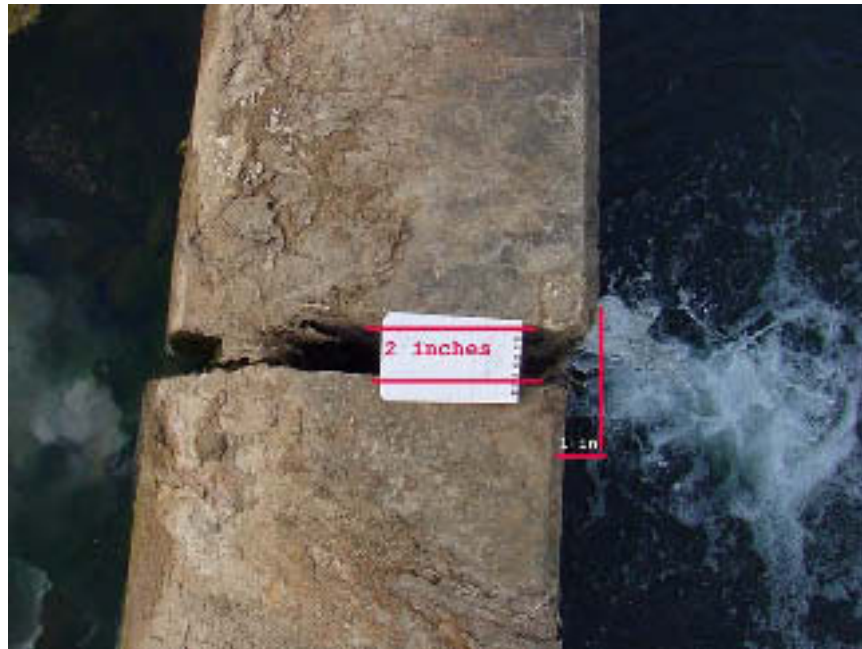
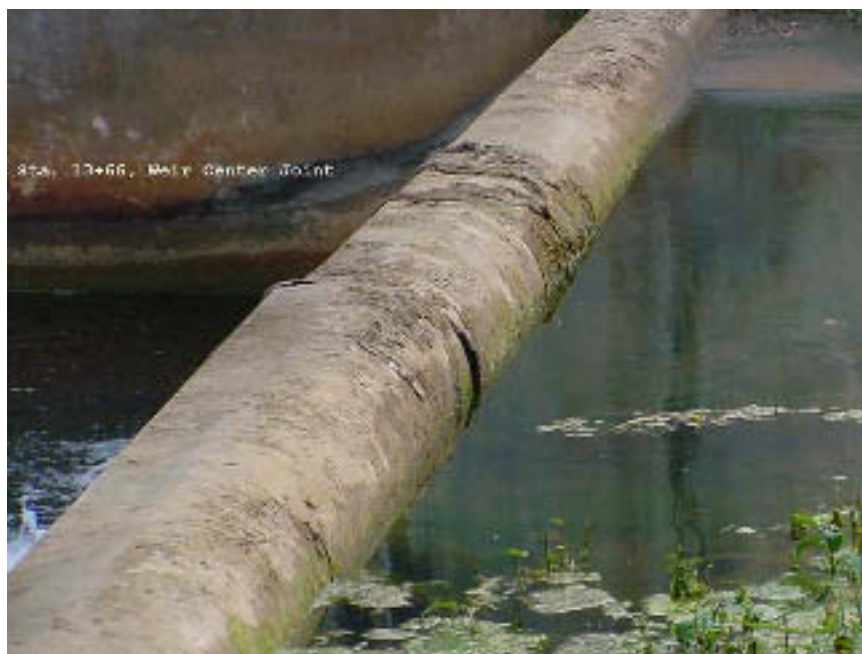
k. Sta. 13+66, Weir, monitor weir gap, the gap has increased .5 inches since the last inspection. (possible cause recent earthquakes).

Same as Above

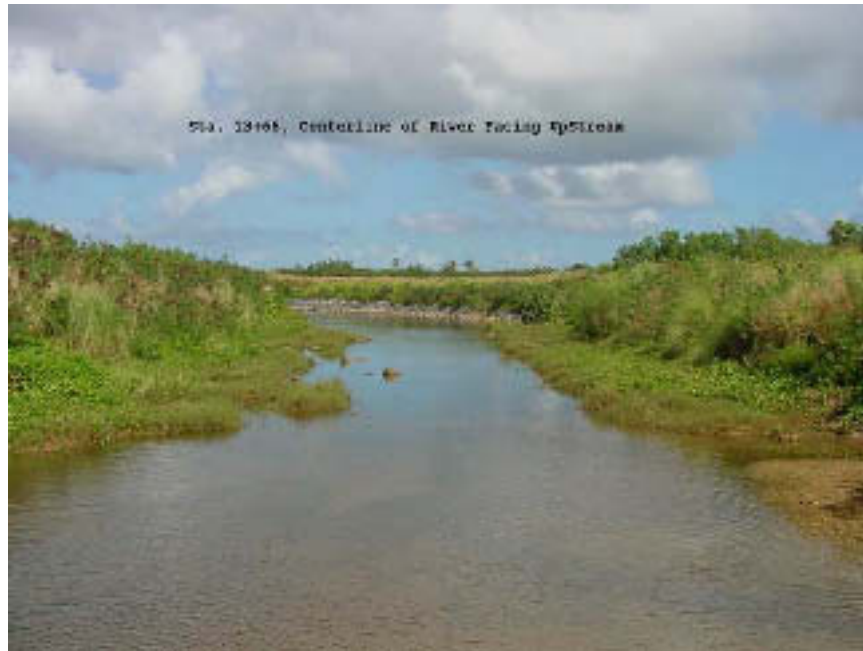
l. Sta. 13+66, Overview of channel, facing upstream, RB & LB, remove vegetation from levee and riprap slope protection, unable to verify riprap placement.

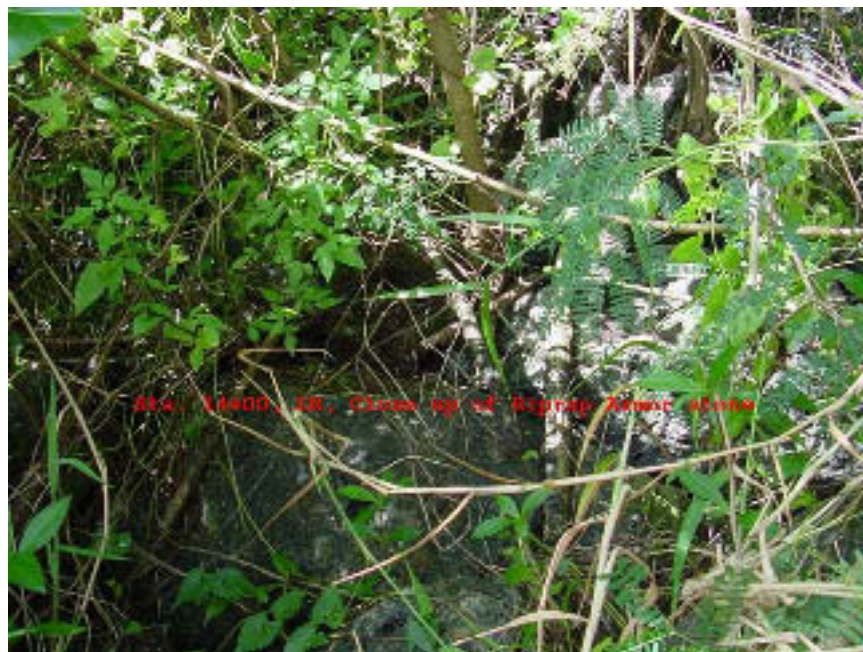
m. Sta. 14+00, LB, Close-up photo of typical vegetative growth on riprap throughout the project.

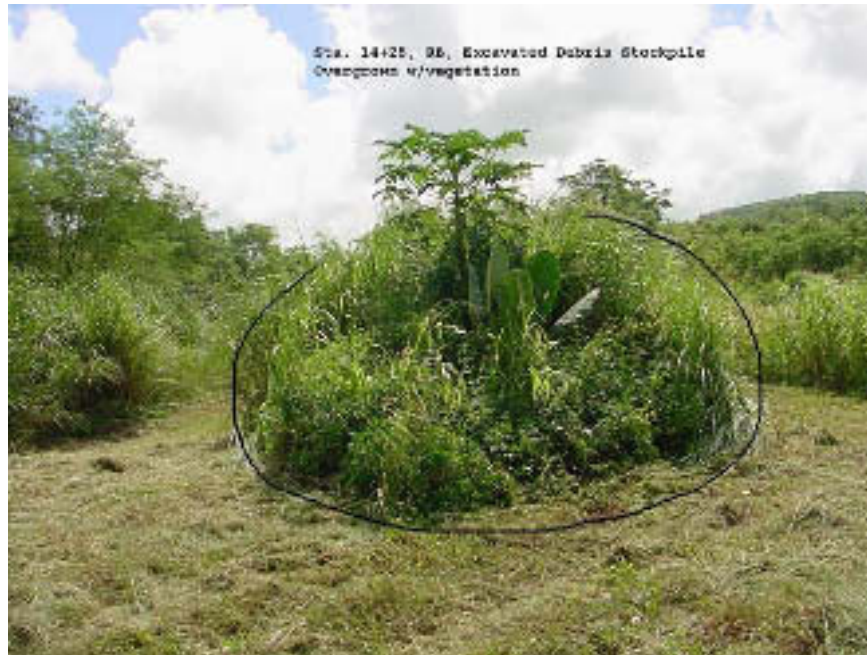
n. Sta. 14+25, RB, remove old excavated material stockpile from levee at approx. 2 locations.

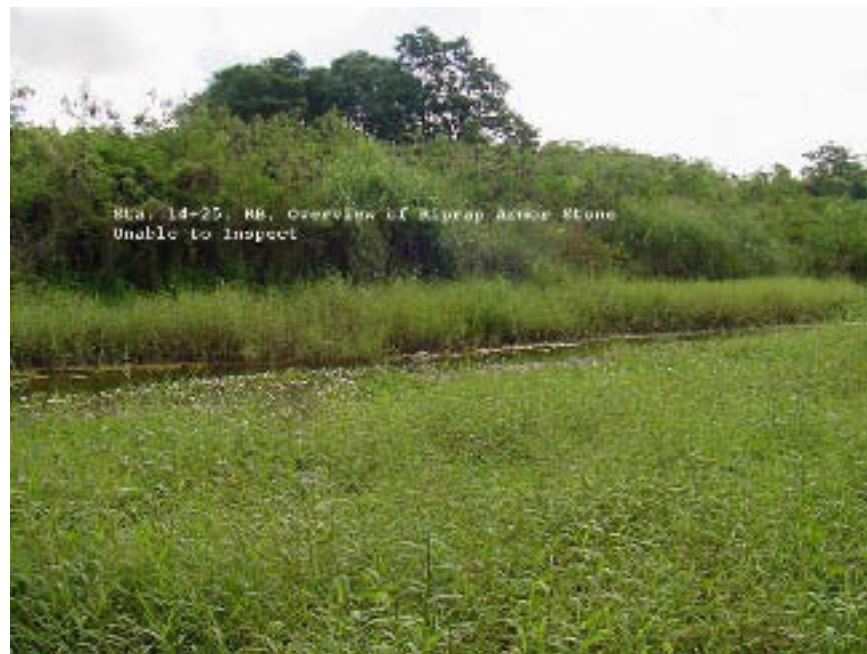
o. Sta. 14+25, RB & LB, remove vegetation from levee and riprap slope protection, unable to verify riprap placement.

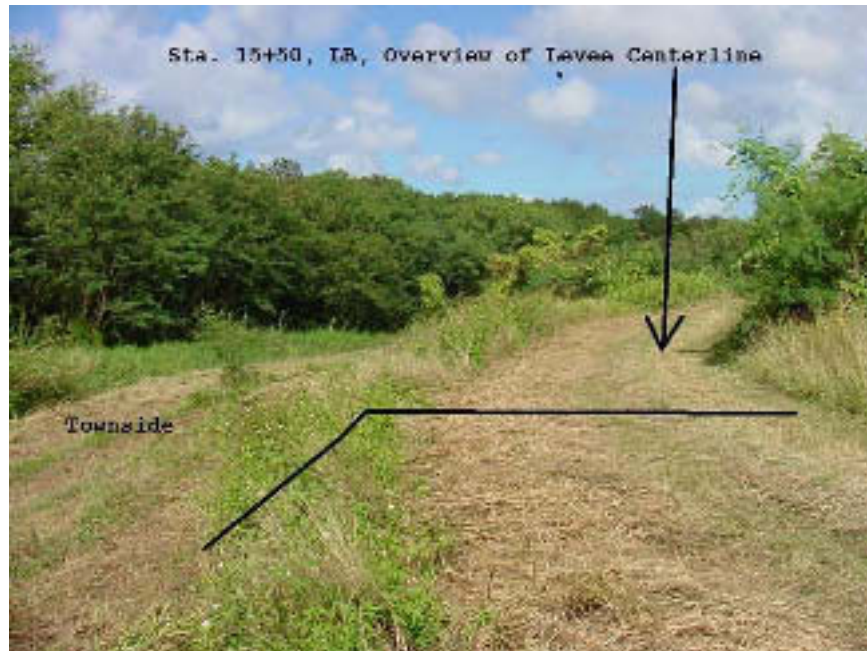
p. Sta. 15+50, LB, Facing downstream, remove vegetation from levee and riprap slope protection, unable to verify riprap placement. (Grass cut on crest during inspection).

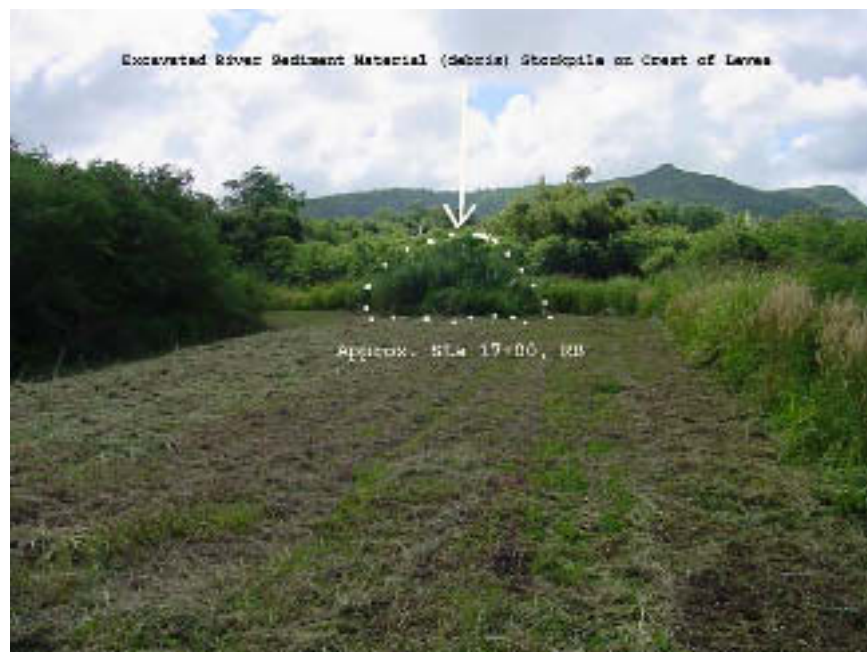
q. Sta. 17+00, RB, remove old excavated material stockpile from levee, continue to re-establish levee crest.

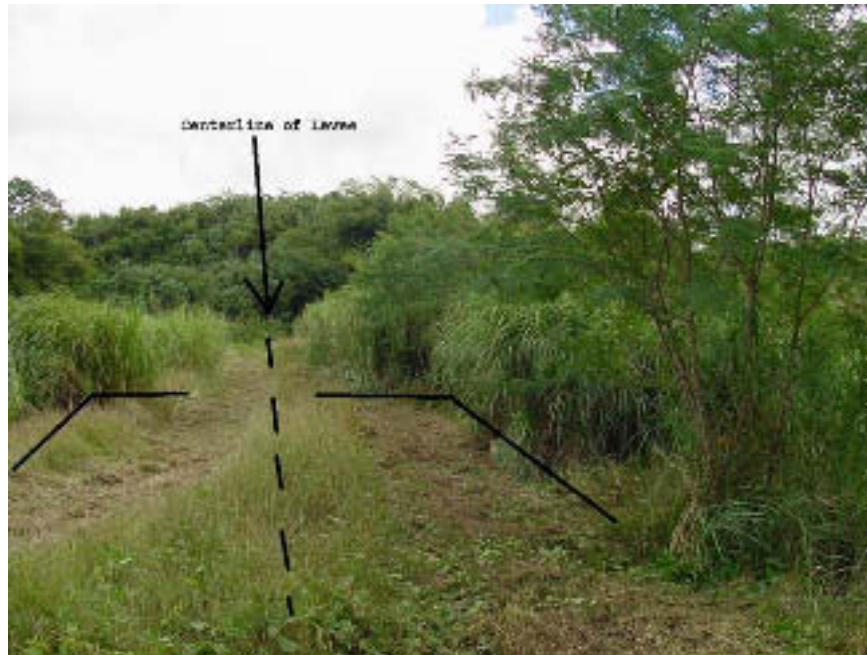
r. Sta. 0+00 - 4+00, Levee, remove all woody vegetation and cut grass on levee sideslopes.

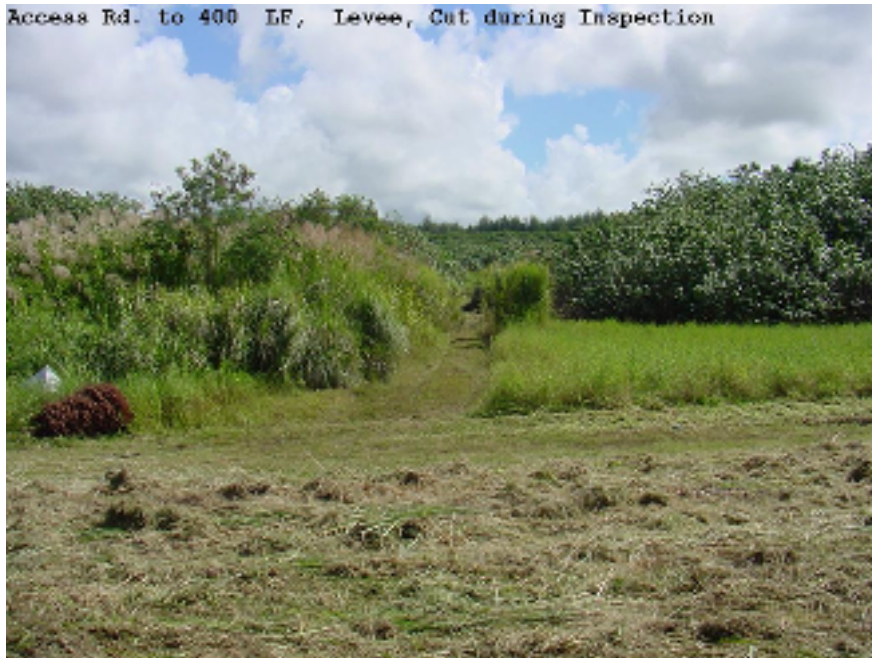
Access Rd. to 400 LF, Levee, Cut during Inspection
